Field Study of Pedestrian Crossings Deterioration Over Time: Assessment of Microplastics Emission from Road Markings

Tomasz E. Burghardt¹ (✉) and Anton Pashkevich²

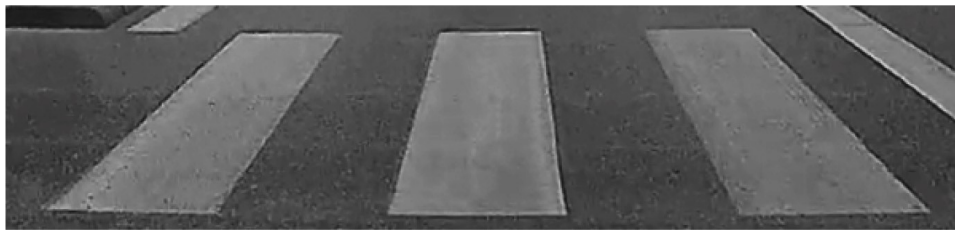
Fig. 1. Exemplary area (crossing B) at the beginning of analysis: circa 2% marking loss since last application (period on the road unknown).

Pictures of one of the analysed pedestrian crossing at the beginning and at the end of the evaluation period are shown in Fig. 1 and Fig. 2, correspondingly; increase in the abraded area is clearly visible.

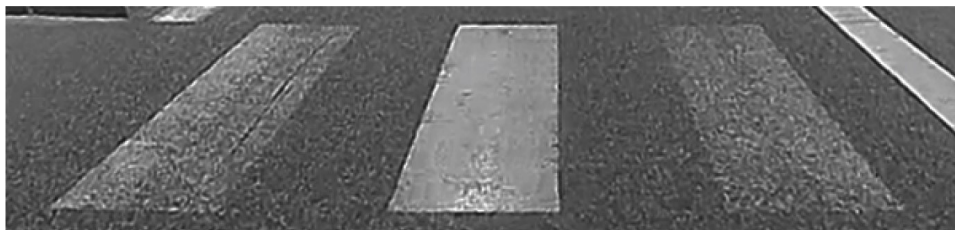
Fig. 2. Exemplary area (crossing B) after 3 years and 23.0 million weight-adjusted vehicle passes: circa 43% marking loss.

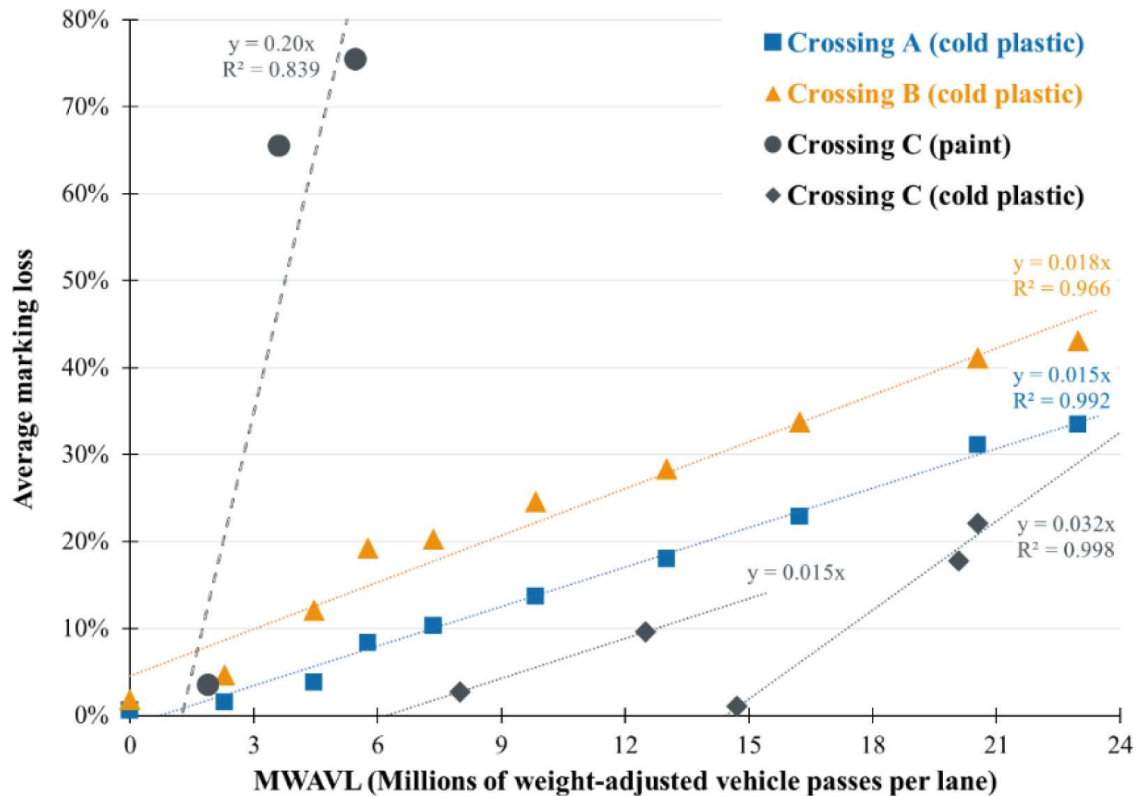
Fig. 3. Marking loss (abrasion) at the analysed pedestrian crossings as a function of traffic load.

The results of the evaluation are summarised in Table 2 and visualised in Fig. 3. One should note the superior performance of cold plastic that was used to mark pedestrian crossings A and B, loss of 1.4–1.8% per MWAVL was measured, which corresponded to estimated polymer emissions of 10.3–12.9 g per MWAVL. At pedestrian crossing C, marked initially with paint, loss of 20.2% per MWAVL was measured (within just several months, average abrasion was 75.5%, but if one excluded the least-used ‘zebra’ stripe, on which almost no vehicles encroach, it was $> 97\%$) for polymer release reaching 14.5 g per MWAVL. Subsequent switch to cold plastic resulted in significantly higher abrasion resistance; however, after another renewal the abrasion rate increased to 3.6% per MWAVL, which indicates that the renewal was not done properly (poor workmanship and/or use of a substandard material).

Validity of this approach and consistency of the collected data was confirmed through comparison of the trendlines drawn through the data points (Cf. Figure 3), where almost parallel trendlines ($y = 0.015x$ – $y = 0.018x$) and good data point fits, with $R^2 > 0.95$, were observed for crossings A and B. Similar result was also seen for the initial application of cold plastic at pedestrian crossing C. Because of apparently poor quality of its renewal, the subsequent slope was steeper ($y = 0.032$; loss 3.6% per MWAVL was measured instead of 1.4–1.8%). The differences between the most used and least used stripes were disregarded for this preliminary assessment, even though they were meaningful; this aspect may be needed for optimisation of the maintenance schedule.
